APPENDIX B**TREND ANALYSIS EXAMPLE**

THIS PACKAGE CONSISTS OF THE FOLLOWING WUCs:

29A7320 - Exhaust pipe
29Q2R - Old WUC for exhaust pipe

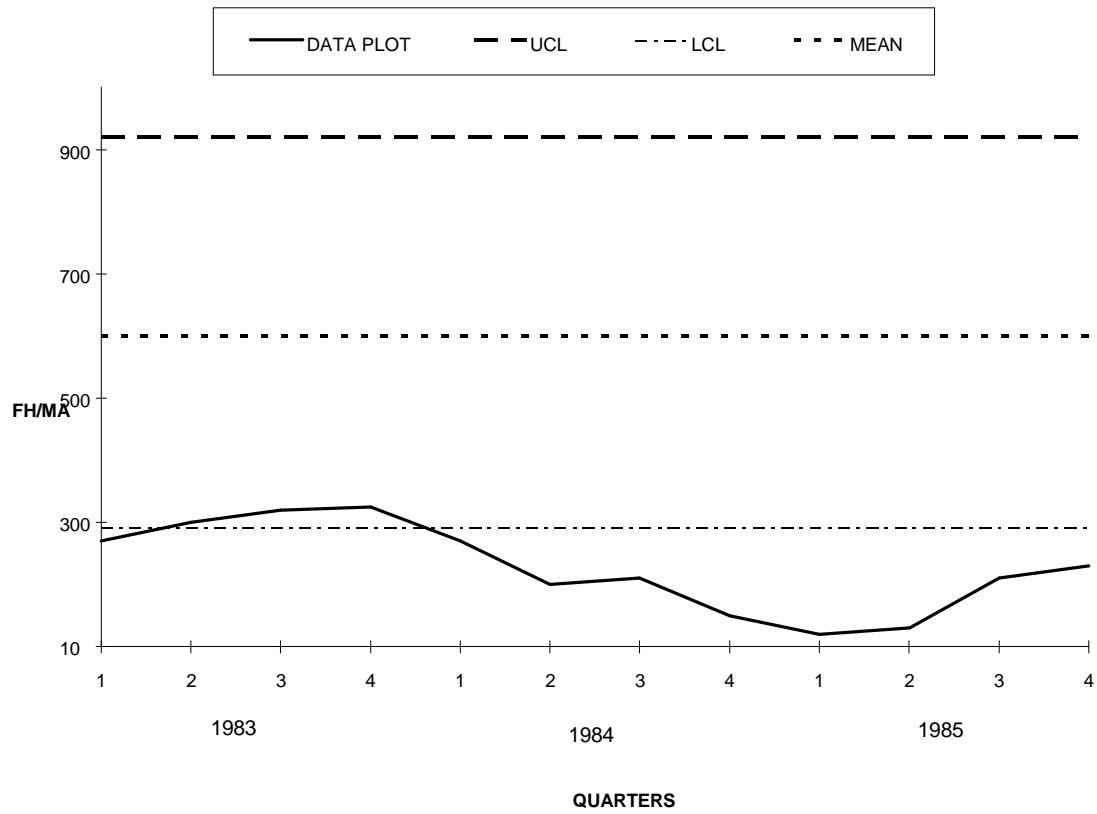
FIGURE 1. Performance Trend - 29Q2R FH/MA TEC AAF

(1) FIGURES 1, 2 and 3 show below LCL for all 4 qtrs of 1985. The first qtr of 1985 appears to be a bottoming point.

(2) Expected improvement is apparently being realized. As the old tail pipes are being replaced continued improvement is expected.

(3) Continue to monitor, if system returns to within baselines, closure may be appropriate.

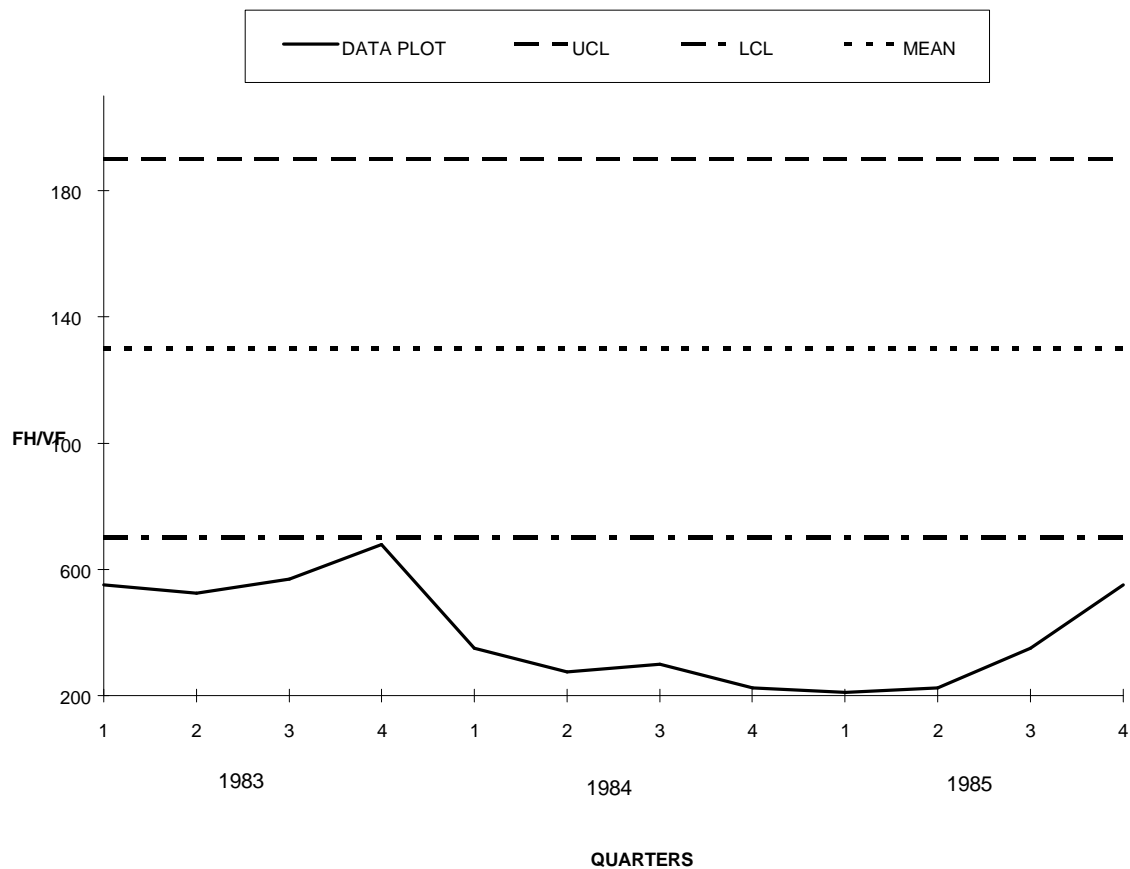
FIGURE 2. Performance Trend - 29Q2R FH/VF TEC AAF

<u>PARAMETER HISTORY</u>	<u>REMARKS</u>
FH/VF	Below lower control limit (LCL) 5 consecutive quarters Downward trend since last quarter of 1982
